Maryland Inventory of Historic Properties number: HA-1880

Name: GLENVIEW RD. OVER MILL BROOK

Maryland Inventory of Historic Properties  
Historic Bridge Inventory  
Maryland State Highway Administration  
Maryland Historical Trust

**Name and SHA No.** H 30 over Mill Brook

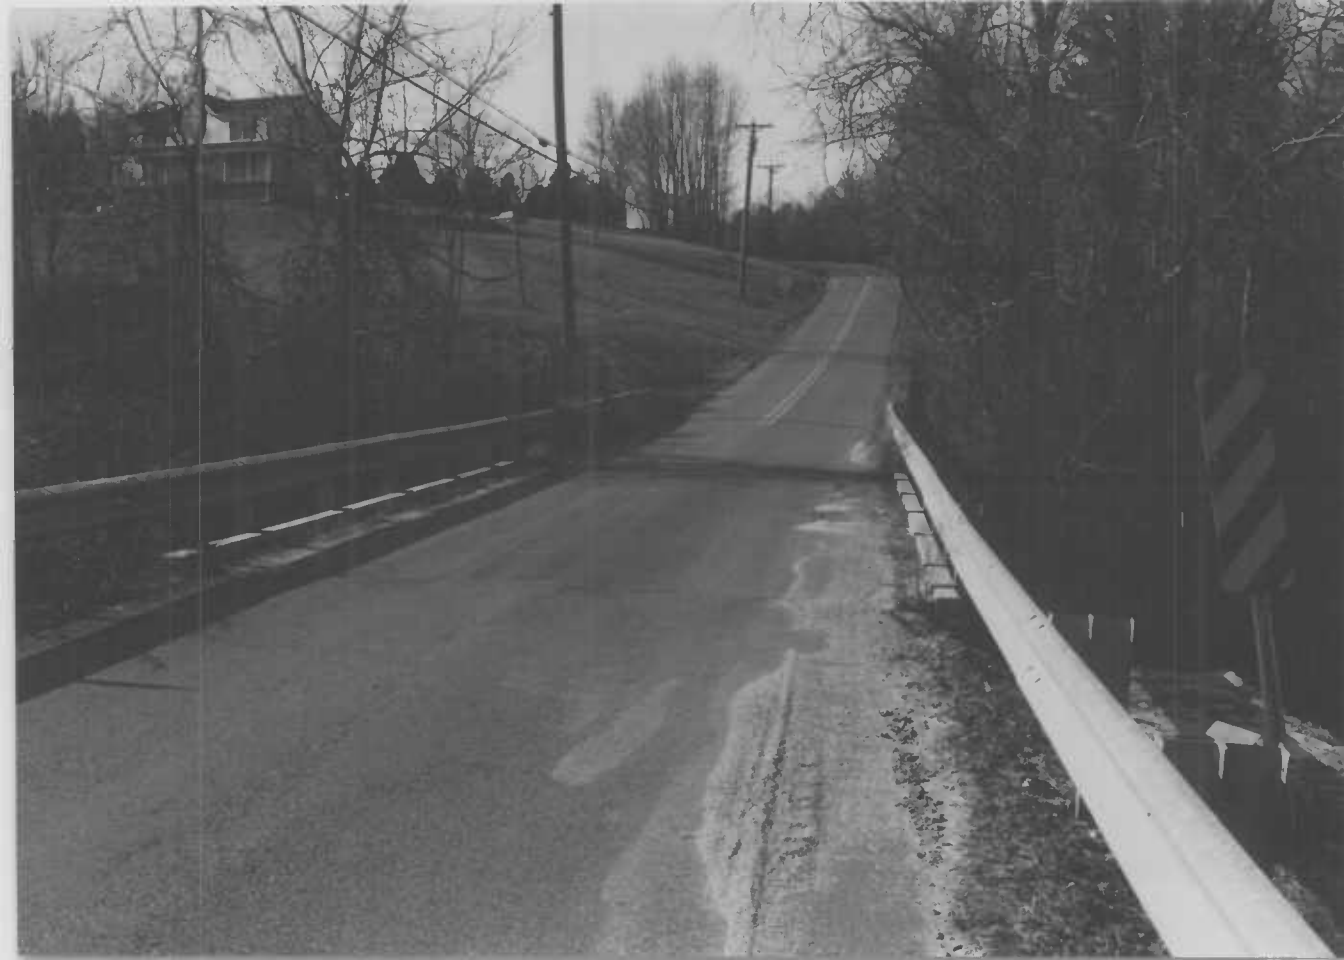
1/4

STATE HIGHWAY BRIDGE 430 OVER MILL  
VIEW LOOKING WEST ON  
GLENVILLE ROAD  
BROOK

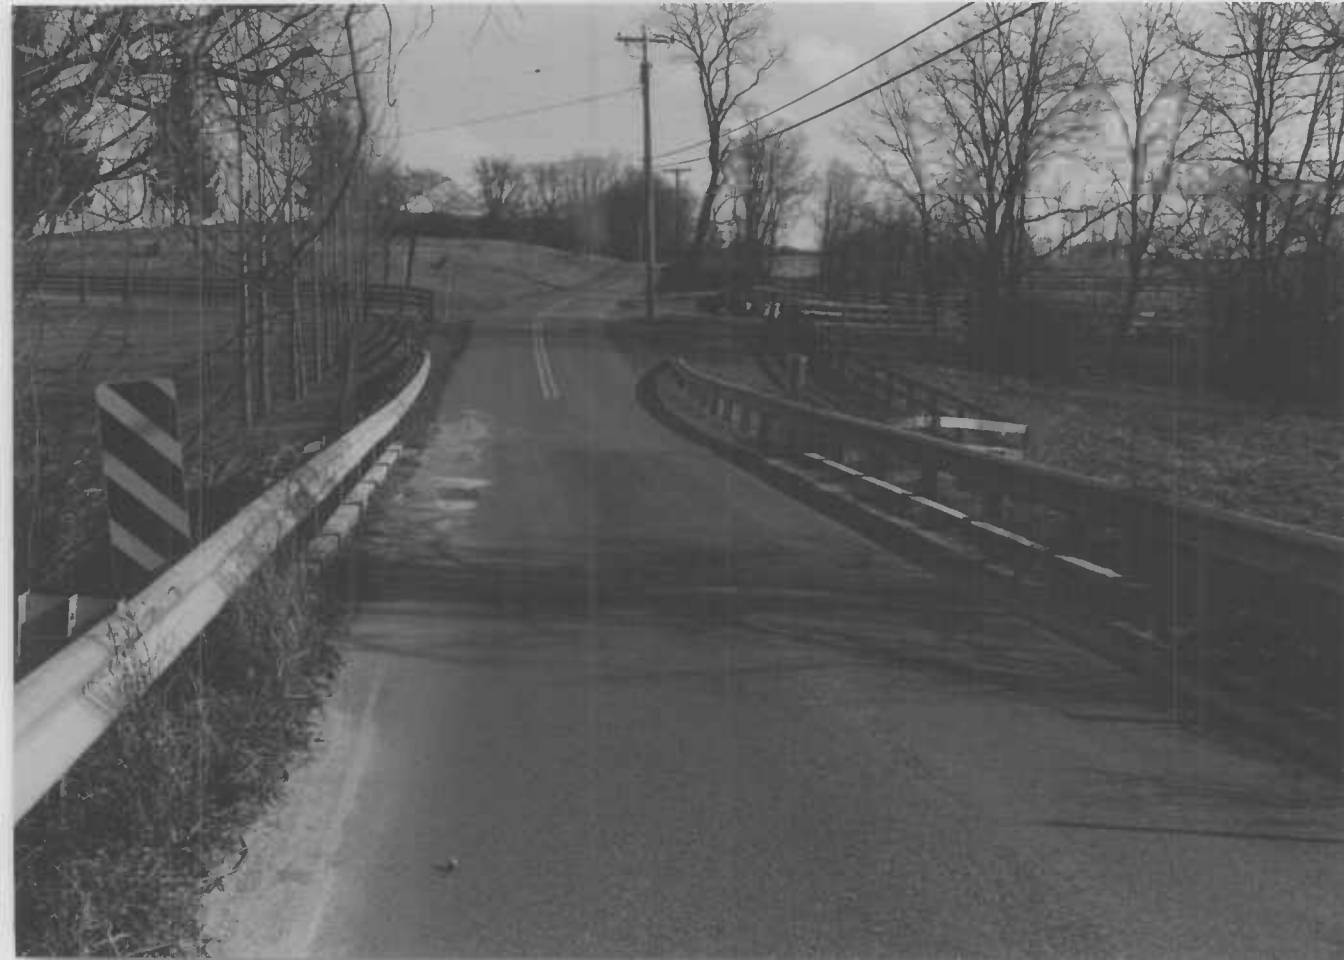
2/4

STATE HIGHWAY BRIDGE H30 OVER

VIEW LOOKING EAST ON MILL BROOK

GLENVILLE ROAD

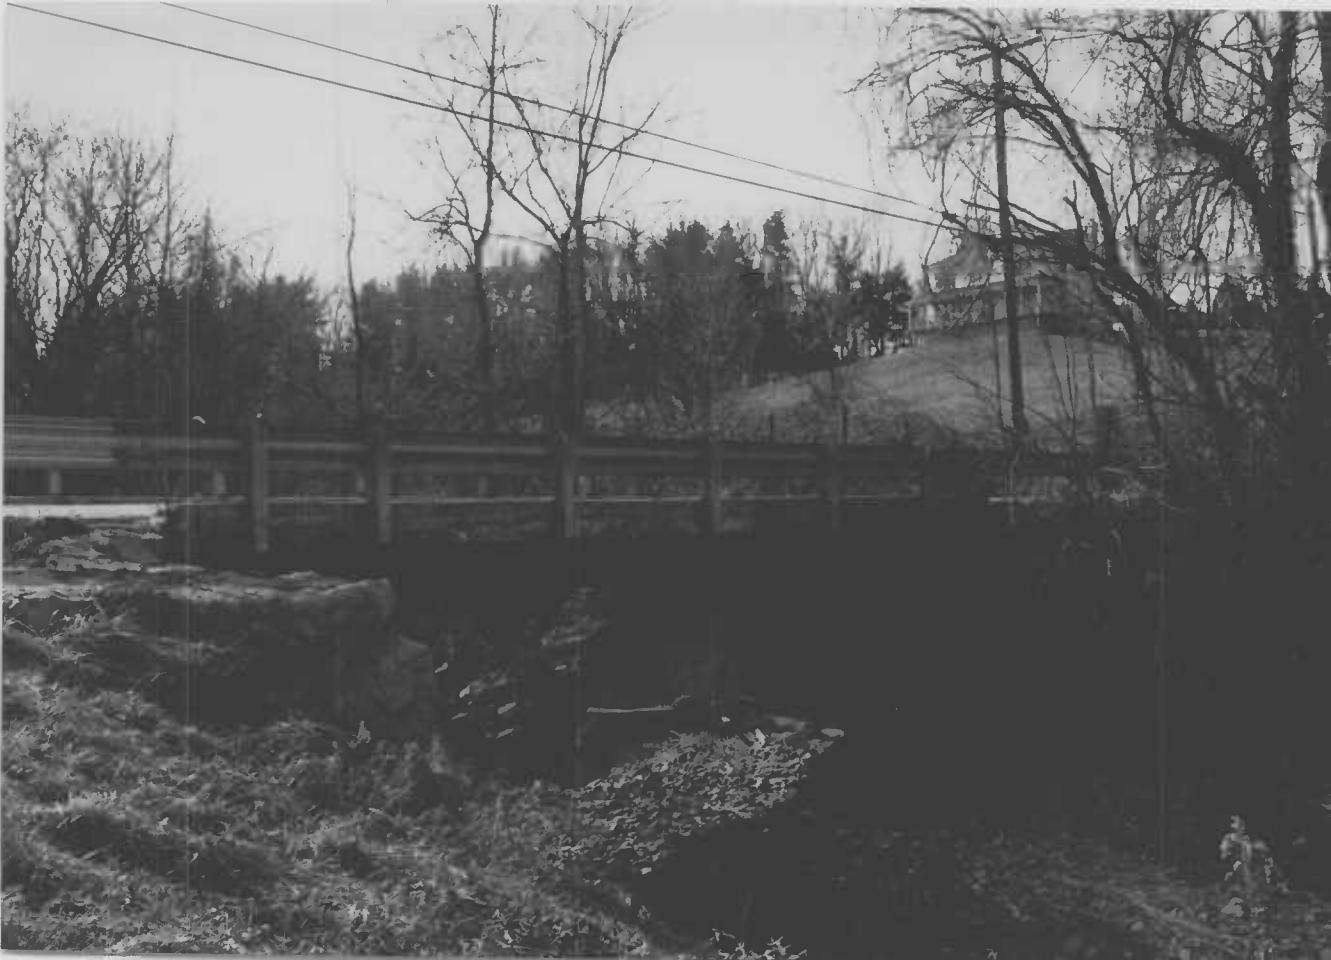
3/4

STATE HIGHWAY BRIDGE H30 OVER  
VIEW LOOKING SOUTH MILL BROOK

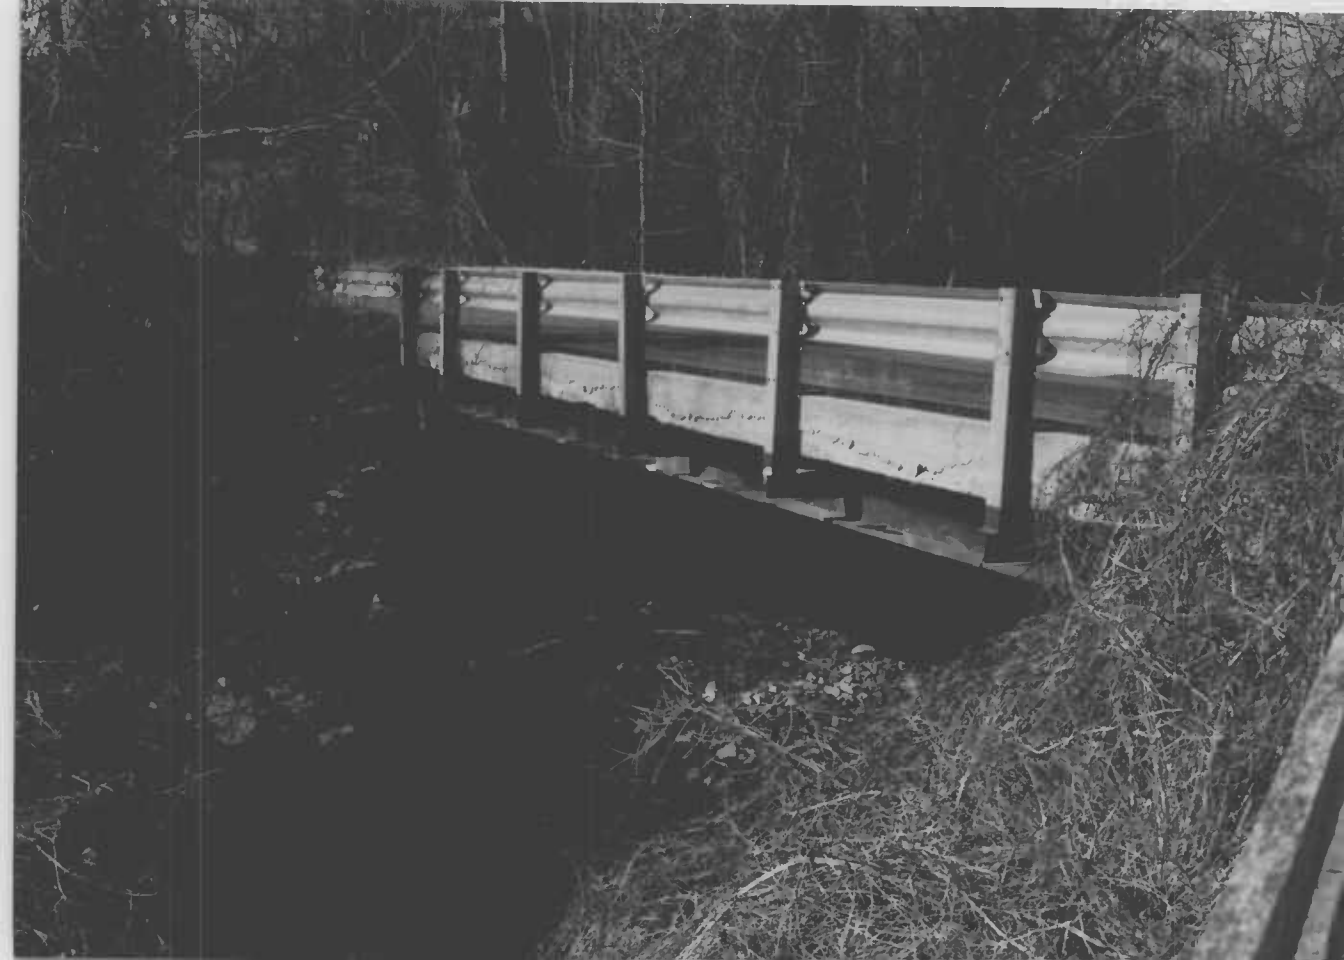
4/4

STATE HIGHWAY BRIDGE H30 OVER  
VIEW LOOKING NORTH HILL BROOK
